Manhole Inspection Summary

Manhole # S33K__005MH

Insp Date: **1/9/09 10:52 AM**

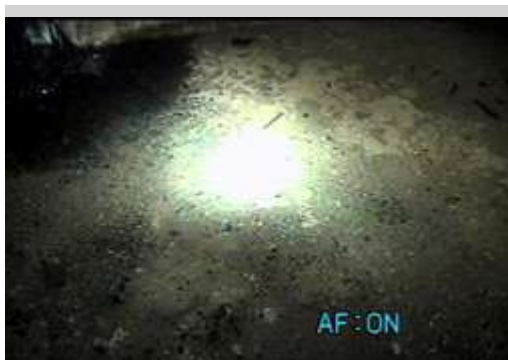
Defect 5

Surcharge ☒ **Evidence Of Surcharge** Depth: **1** (ft.) ☒ **Active Surcharge Present**

surcharge active, because 12 pipe is up too high

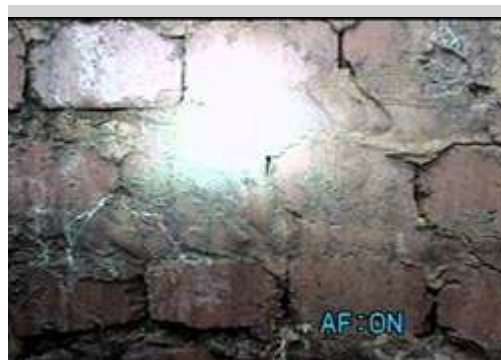
Defect 4

Condition: ☐ Sound ☒ **Cracked** ☒ **Root Intrusion** ☐ Loose Brick ☐ Deteriorated

cracks in corbel

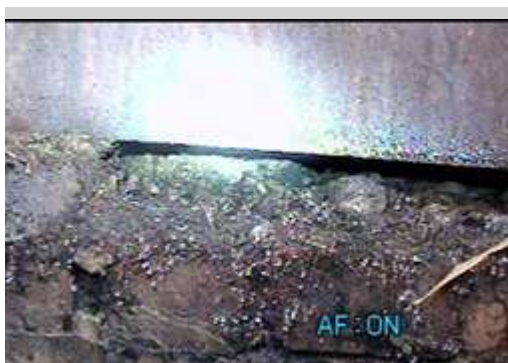
Defect 3

Infiltration: ☐ None ☐ Joint ☐ Cracks ☐ Mortar ☒ **Roots** ☐ Wall

infiltration from roots in corbel

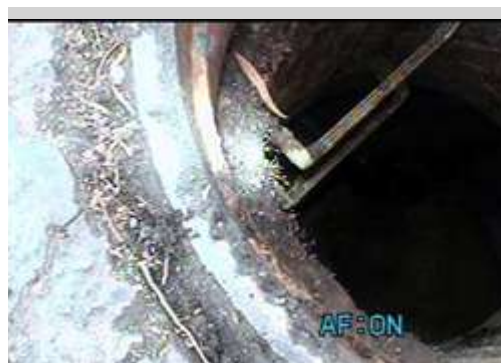
Defect 2

Frame Offset: **2** (in.) Condition: ☒ Sound ☐ Cracked ☐ Leaks

frame offset 2 inches

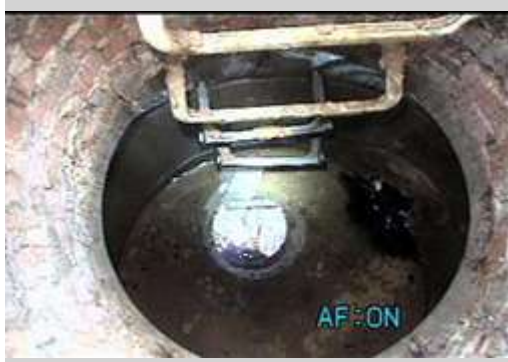
Defect 1

Steps Count: **4** Missing: **0** ☒ **Corroded**

steps corroded

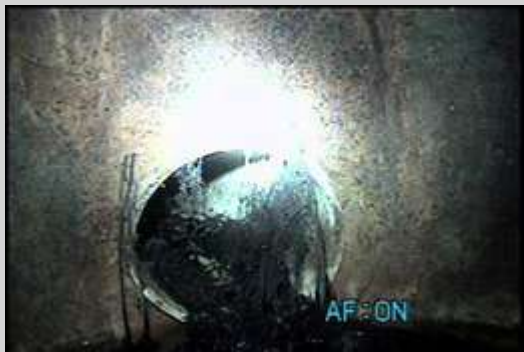
12 O'Clock Outflow

Deposits: ☐ None ☐ Mud ☒ Gravy ☒ Debris ☐ Grease

Silt Depth: 4 (in.) Deposits Extent: Medium
